Your Inspection Report

4138 Forest Fire Cres Mississauga, ON L4W 3T5

INSPECTION DATE: Wednesday, June 12, 2019

RE: Report No. 67829 4138 Forest Fire Cres Mississauga, ON L4W 3T5

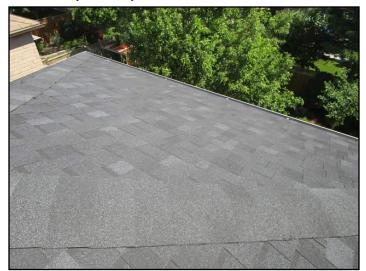
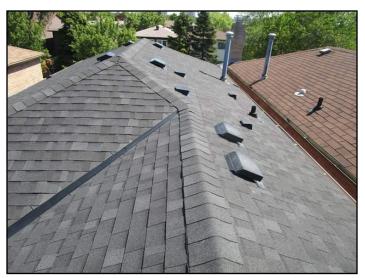
The roof covering appears to be within the first half of its normal life expectancy. These asphalt shingles are premium quality and may be expected to last longer than conventional shingles.

Roof coverings wear out and are replaced...

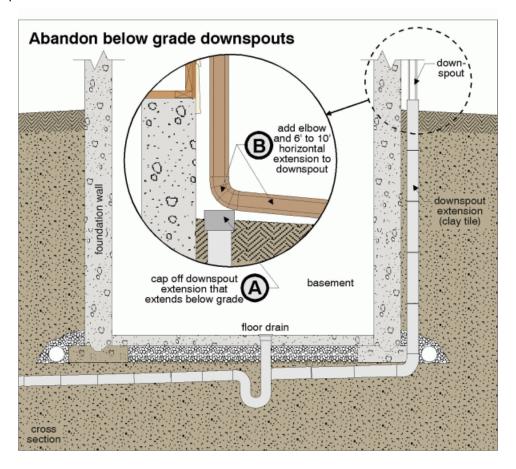
Condition: • Discharge below grade

While the current arrangement is convenient and a good method to deal with rain water, if the drain pipe becomes clogged and/or deteriorated, there is a greater risk of water backing up and leaking into the basement. Note: On newer houses the drain may go into the weeping tile (not the floor drain).

Task: Correct

Time: As soon as practical

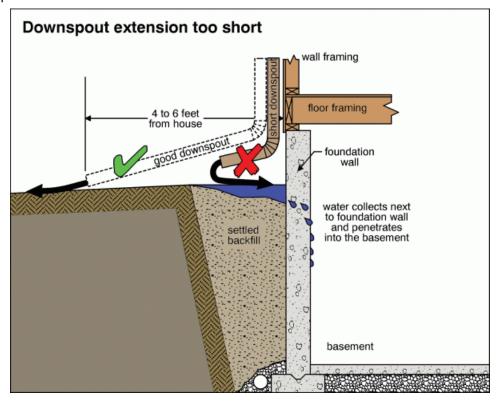
Condition: • Discharge too close to building

Task: Correct

Time: As soon as practical

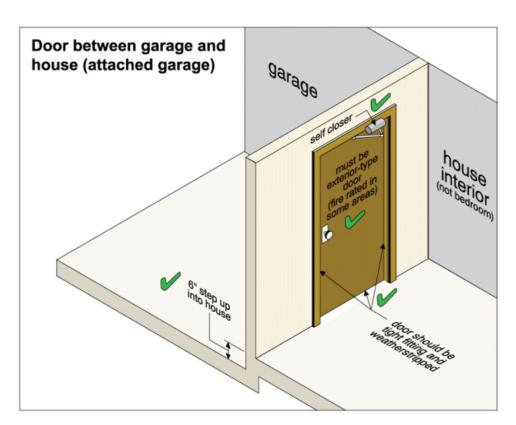
Condition: • No self-closer

Task: Provide
Time: Immediate
Cost: Minor

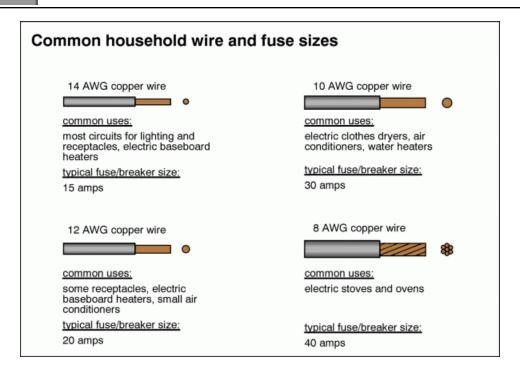
Condition: • Fuses or breakers too big

*40amp breaker with smaller sized wire noted. This may be perfectly acceptable as some appliances tend to momentarily draw more amperage during start-up, but further evaluation by a qualified electrician is recommended.

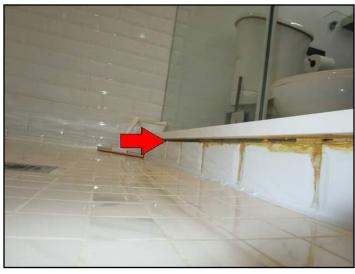
Condition: • Grout loose, missing or deteriorated

*Grout/sealant ineffective, missing or deteriorated at shower threshold.

Grout loose, missing or deteriorated

Task: Seal

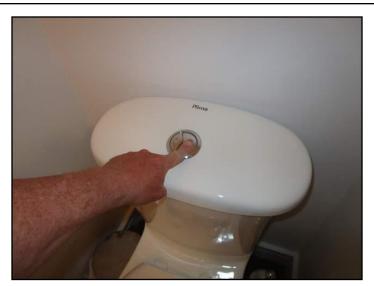
Condition: • Flush mechanism inoperative Large flush button stiff/difficult to operate.

Flush mechanism inoperative

Task: Repair

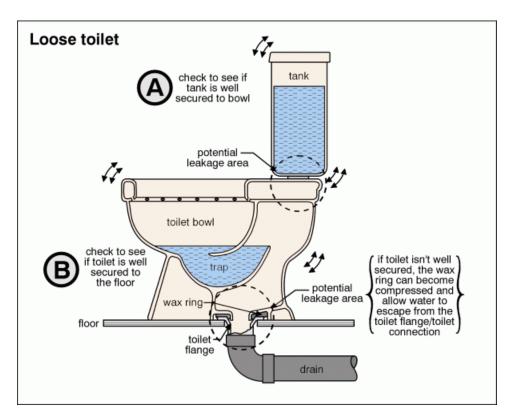
Condition: • Loose

Location: Hallway Bathroom and Master Bathroom

Task: Secure
Time: Immediate

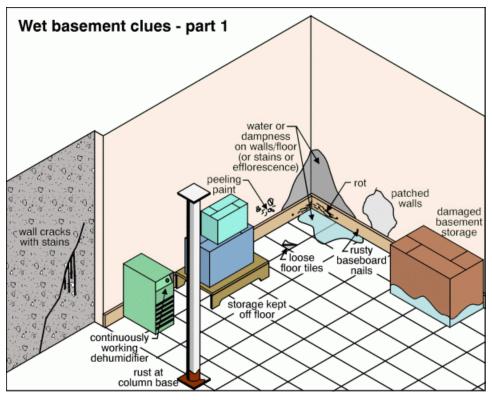
Condition: • Dampness on floor or walls

Slightly elevated moisture levels noted in this area of the basement. Follow the steps in this section to systematically improve the exterior as best possible to divert as much moisture as possible away from the house. Cost will increase as you proceed down the list. Generally speaking, controlling your downspouts and providing improved grading will offer the most benefit for the least cost. See other comments in Exterior and Interior sections for best strategies to minimize the potential for future water problems in the basement. A dehumidifier is also advised (especially for the summer).

Location: Northwest
