Your Inspection Report

24 Blair Athol Cres
Toronto, ON M9A 1X5

INSPECTION DATE:
Friday, January 31, 2020

RE: Report No. 70857
24 Blair Athol Cres
Toronto, ON
M9A 1X5

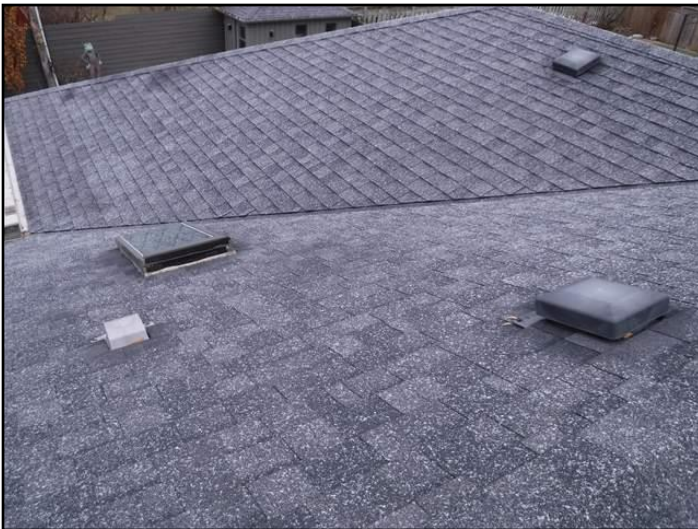
Condition: • Asphalt shingle roof coverings wear out and are replaced every 15 years or more, depending on a number of variables. An annual roof tune-up by a qualified roofer is strongly recommended.

Asphalt shingle roof coverings wear out and...

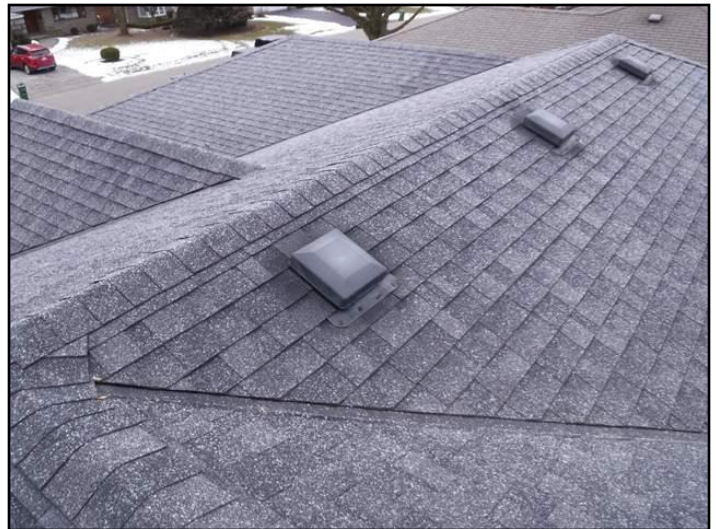
Asphalt shingle roof coverings wear out and...

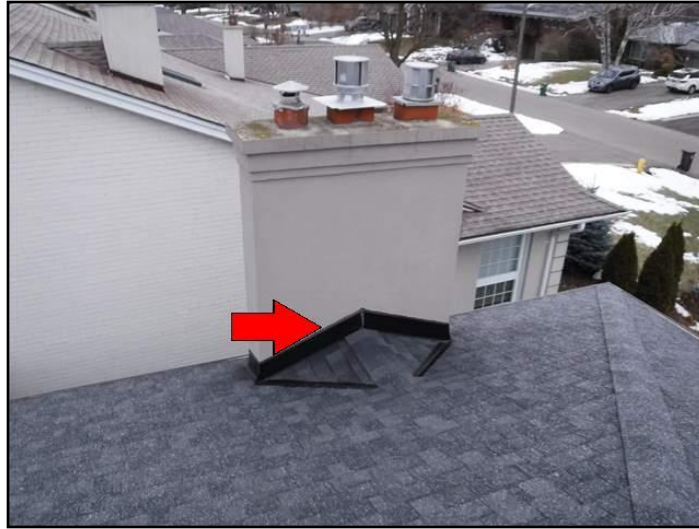
Condition: • [Damage, loose, open seams, patched](#)

*Caulking deteriorated/ineffective.

Caulking deteriorated/ineffective

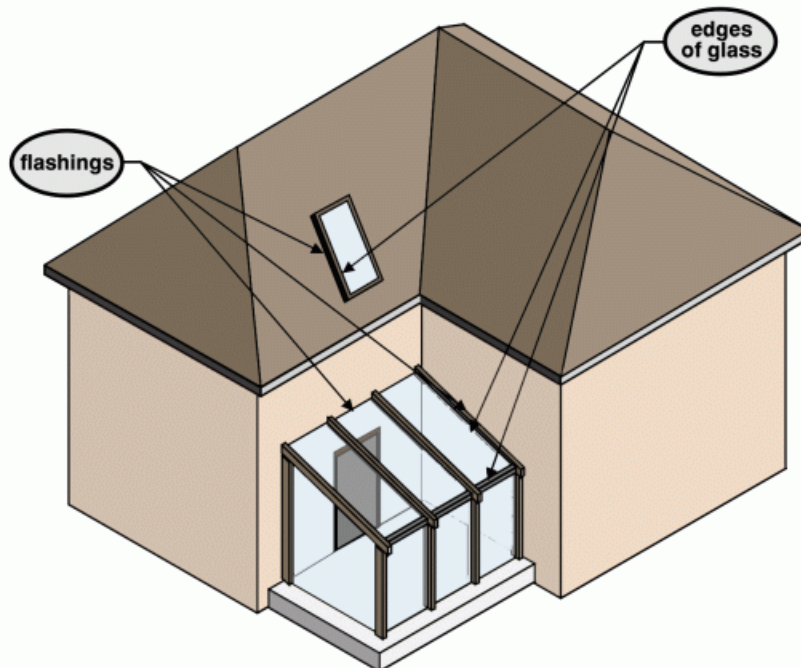
Skylight and solarium leaks

Condition: • Skylight(s) - vulnerable area for leaks.

skylights and solariums are very prone to leakage
leakage typically occurs through the flashings or at
the edges of the glass

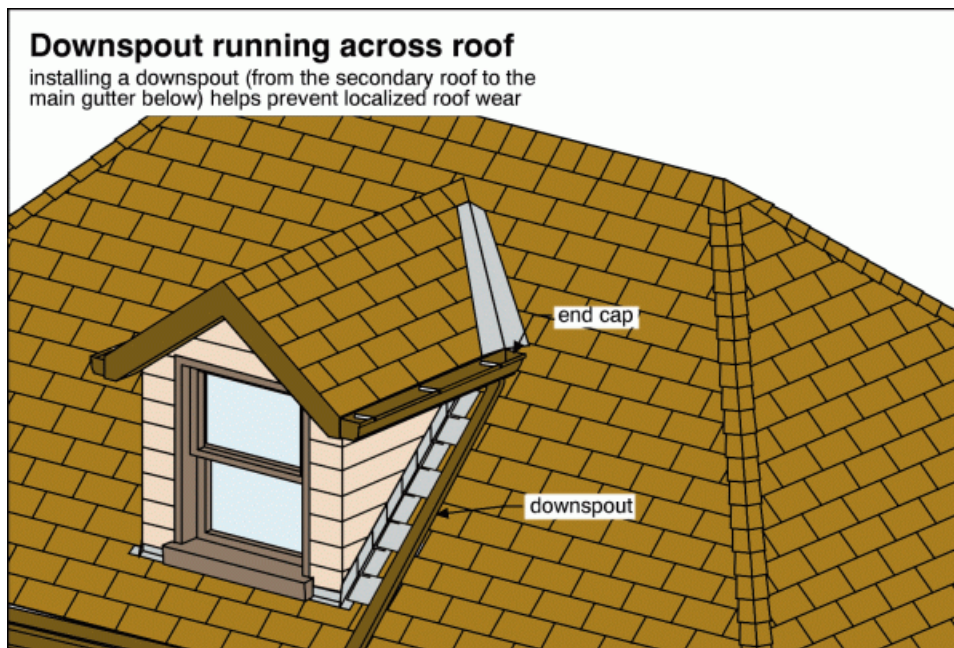
Condition: • [Discharge onto roofs](#)

*Upper roof discharges onto lower roof - In order to help prevent pre-mature wear of lower shingles, downspout extension(s) into the gutter system below are recommended.

**Gutter end caps missing - provide as required.

Time: Less than 1 year

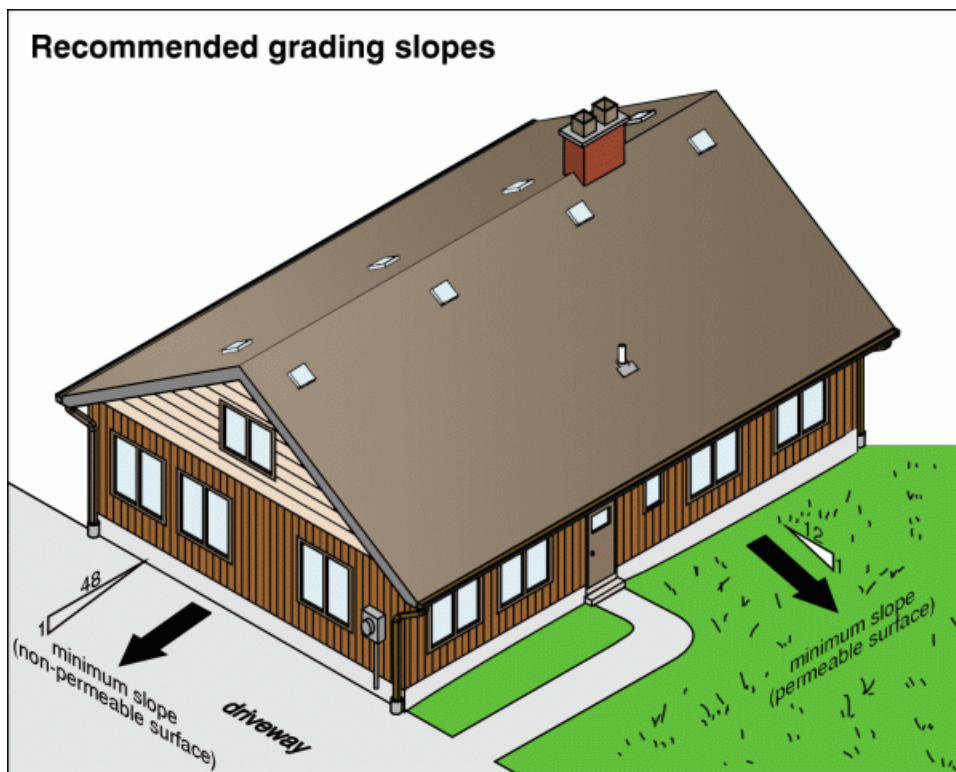
Condition: • The grading around portions of the house is relatively neutral.

*Lot grading is generally flat near the home, which is better than draining towards the home, but not as good as draining away from the home. Poor lot grading can contribute to basement leakage. Monitor the drainage in these areas and re-slope them if necessary.

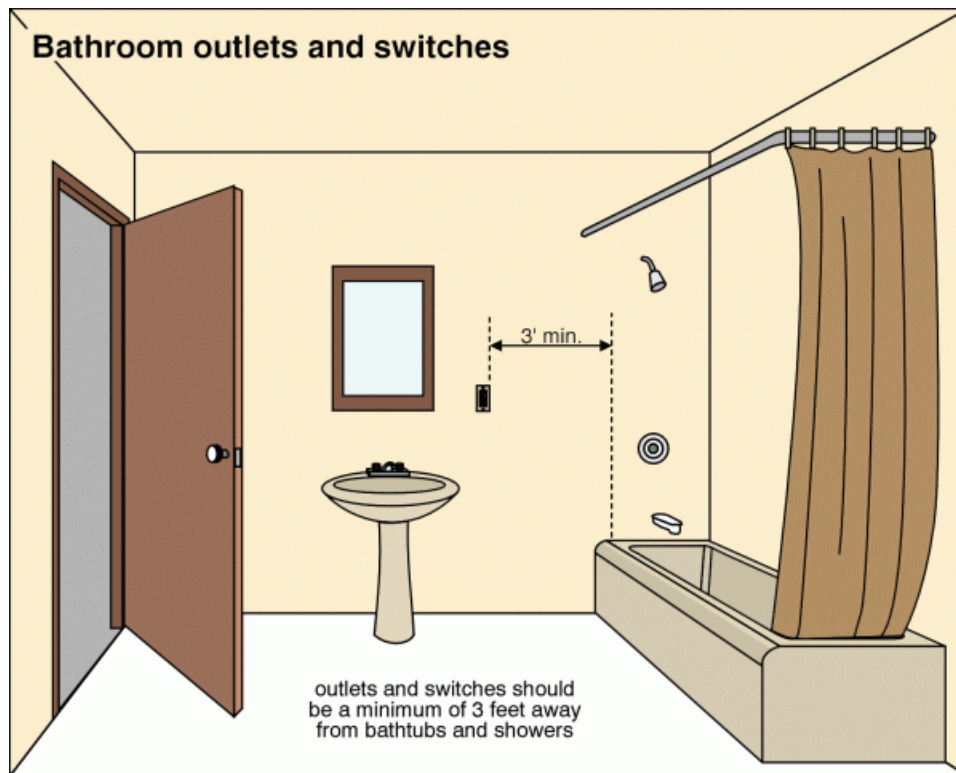
Location: Basement Bathroom

Condition: • [Location poor \(near Bathtub or Shower Stall\)](#)

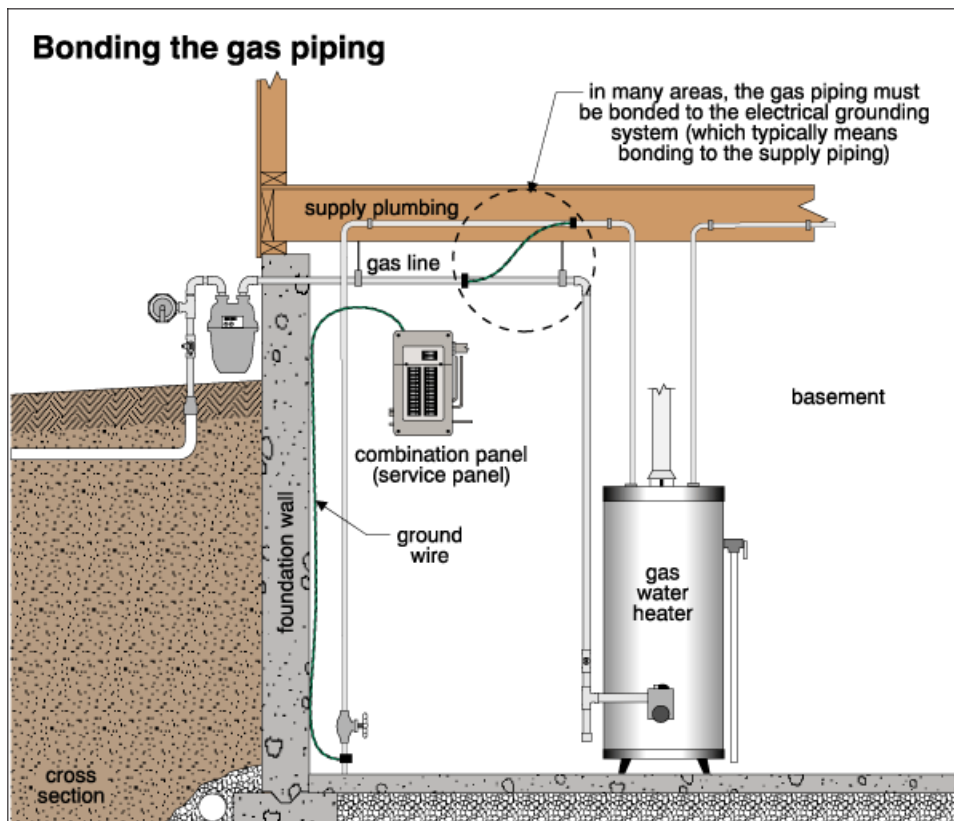
Condition: • Piping not properly bonded

*Bonding wire not visible to gas furnace or water heater.

Task: Seller to correct

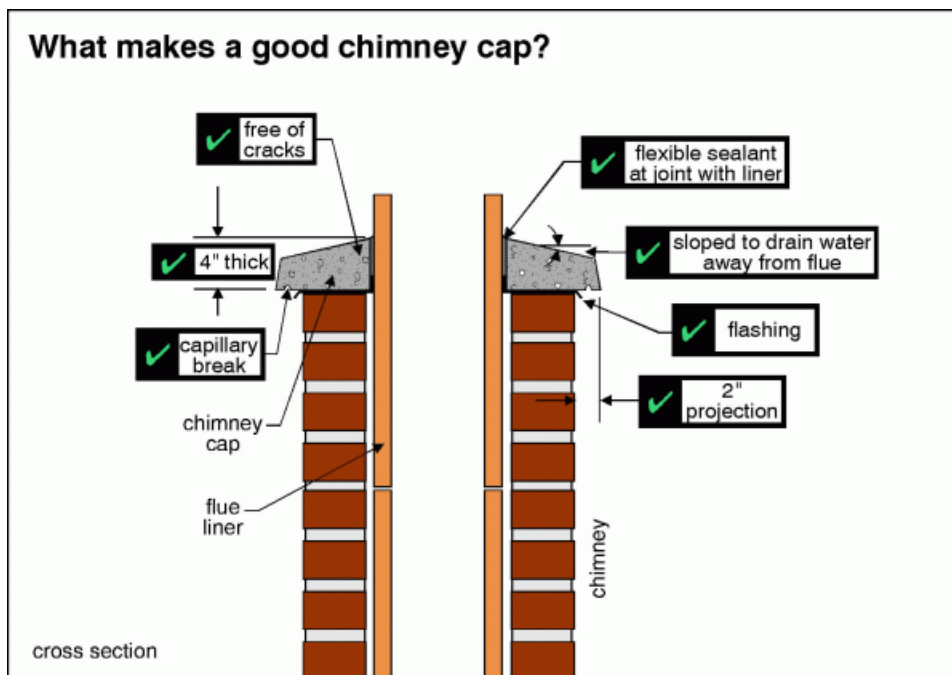
Condition: • [Cracked](#)

*Ensure sealant around base of clay flues is kept in good condition.

Task: Repair/ Seal

Time: Less than 1 year

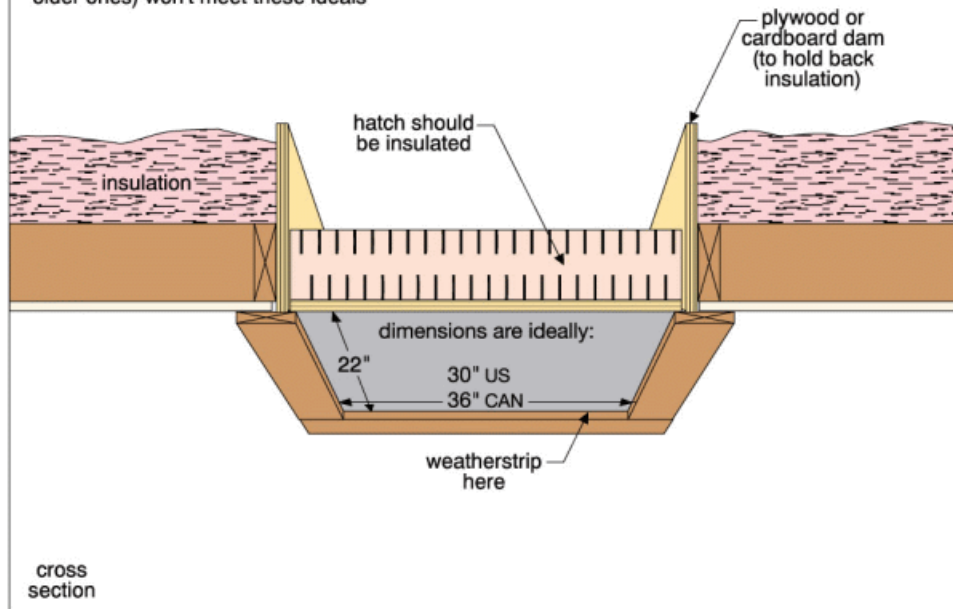
Condition: • Access Hatch: weatherstripping/fit less than ideal

the illustration shows a good attic access hatch design

hatches in many houses (especially older ones) won't meet these ideals
