Your Inspection Report

55 Twyford Rd
Etobicoke, ON M9A 1W5

INSPECTION DATE:
Wednesday, May 27, 2026

RE: Report No. 97724
55 Twyford Rd
Etobicoke, ON
M9A 1W5

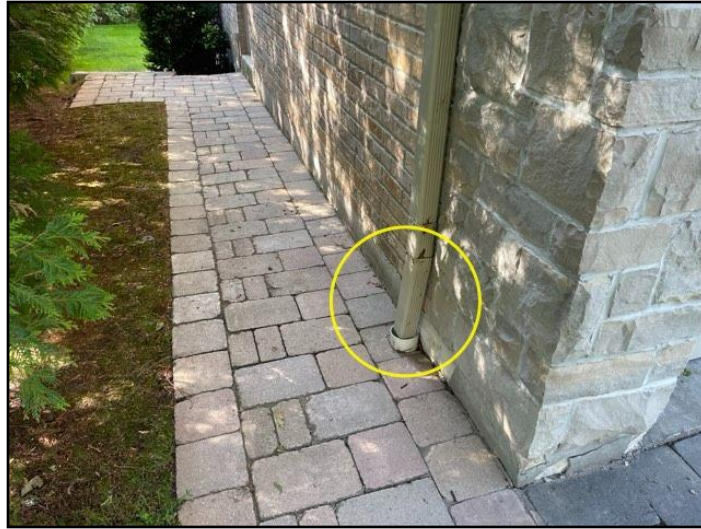
Toronto - Discharge below grade

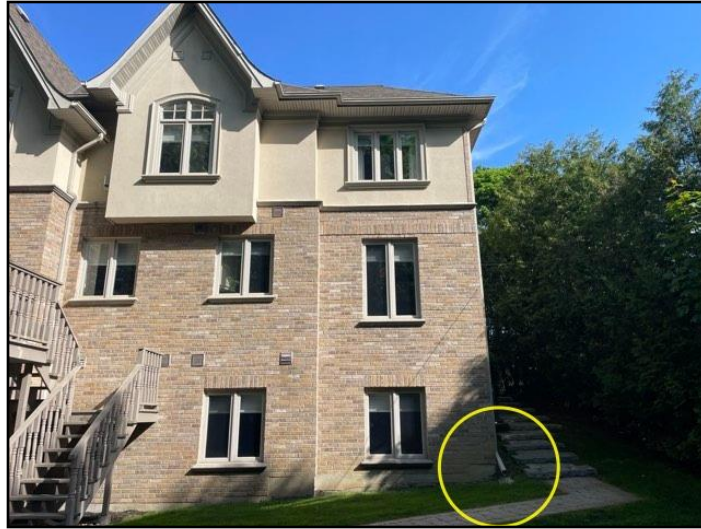
Condition: • [Discharge too close to building](#)

Always transfer water as far away from the house as practical. However, attention to erosion, tripping hazard, or creating a slippery ice surface should also be considered.

Discharge too close to building

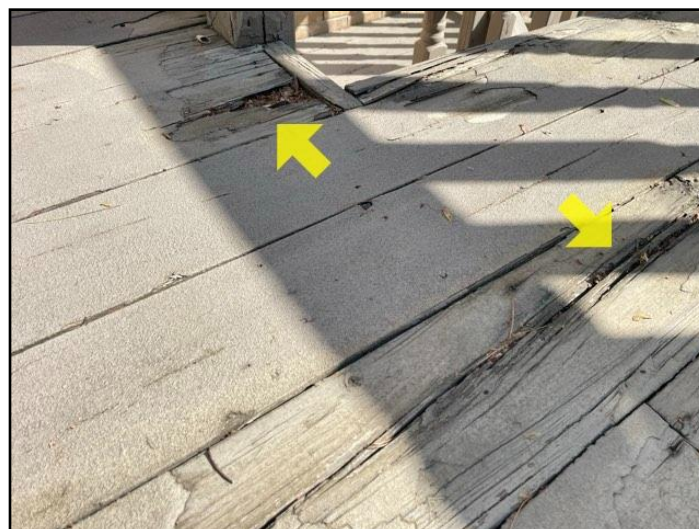
Condition: • [Rot](#)

Location: Rear Deck

Rot

Task: Repair

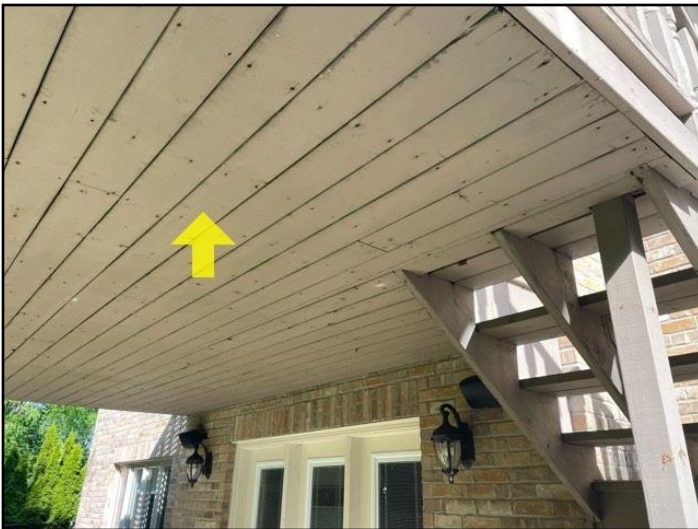
Condition: • Underside covered
May be impeding drainage
Location: Rear Deck
Task: Remove covering / Further evaluation
Time: Less than 1 year
Cost: Not determined

Underside covered

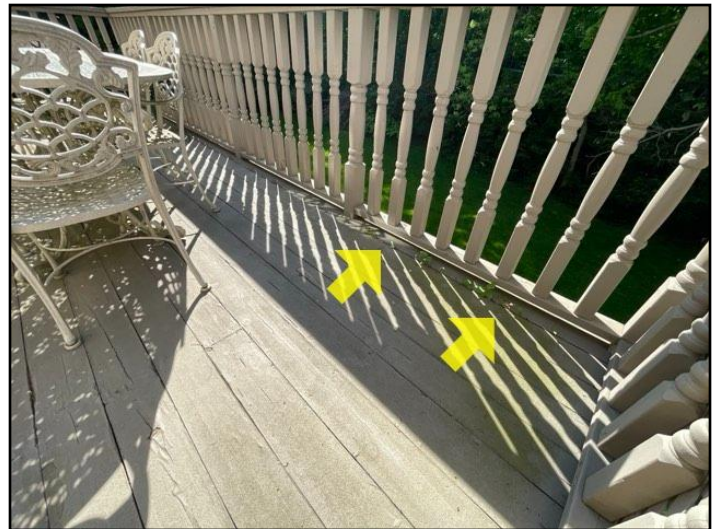
Growth on top

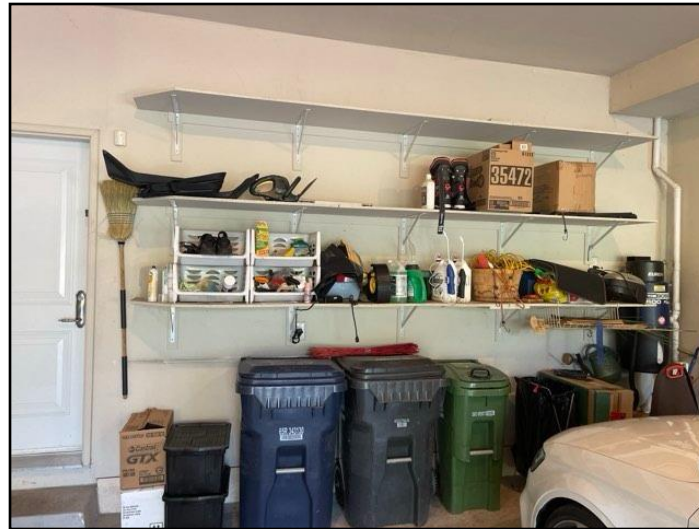
Condition: • Shelving - load capacity not determined
Task: Verify
Time: Before using

Shelving - load capacity ND -

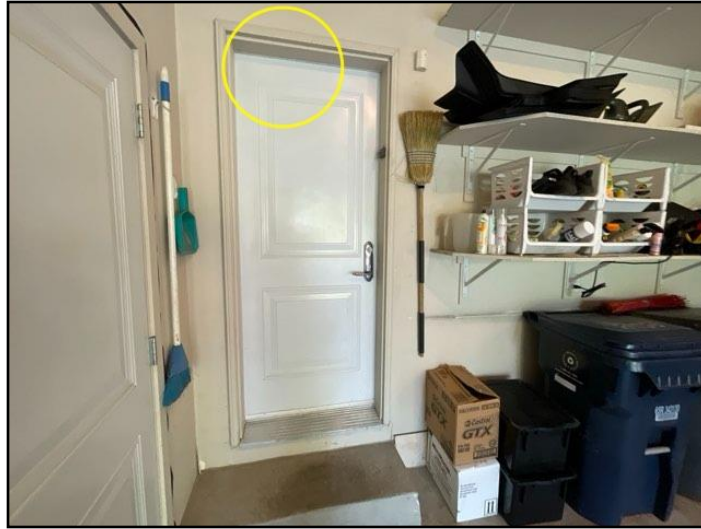
Condition: • Door closer - missing

Door closer - missing

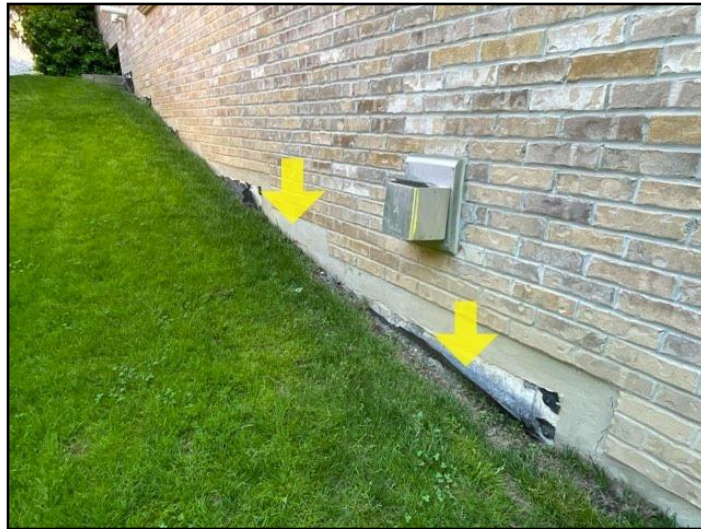
Condition: • Evidence of exterior basement waterproofing was noted. This suggests corrective action has been taken to address leakage. No evidence of leakage was noted on the building interior at this location at the time of the inspection.

Evidence of water proofing

Task: Monitor the basement in this area of the home for leakage.

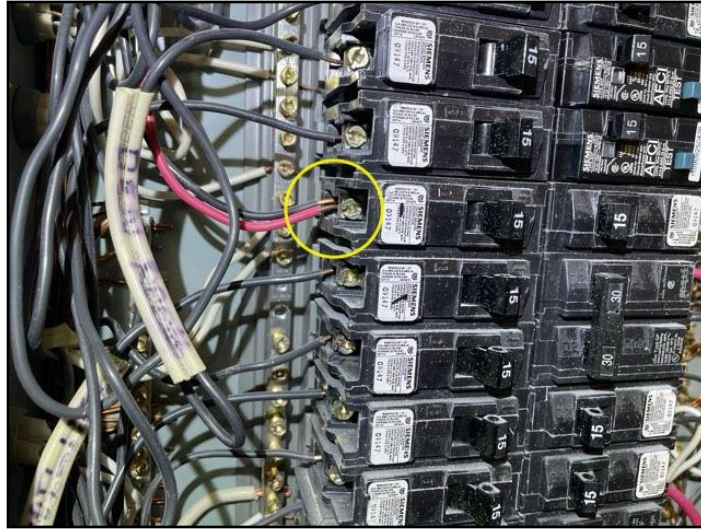
Condition: • [Double taps](#)

Double taps

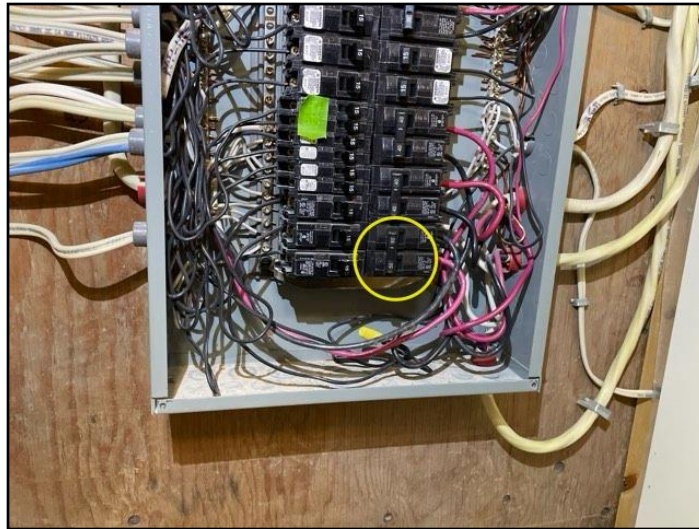
Condition: • [Fuses or breakers too big](#)

Fuses or breakers too big

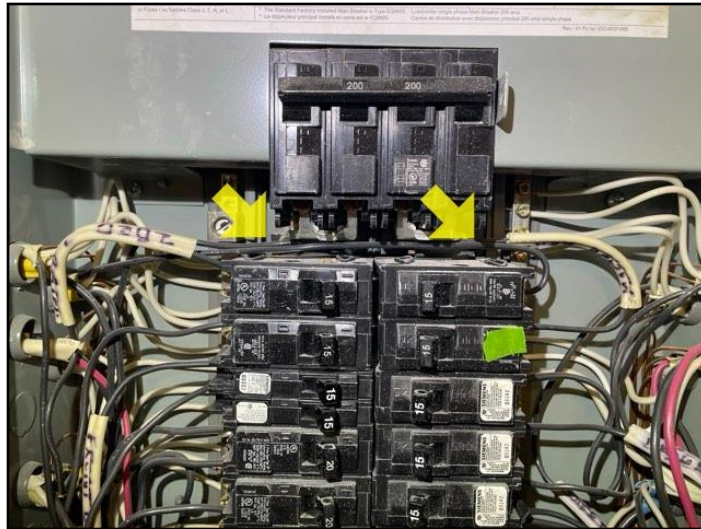
Condition: • [Wire crossing bus connections](#)

Wire crossing bus connections

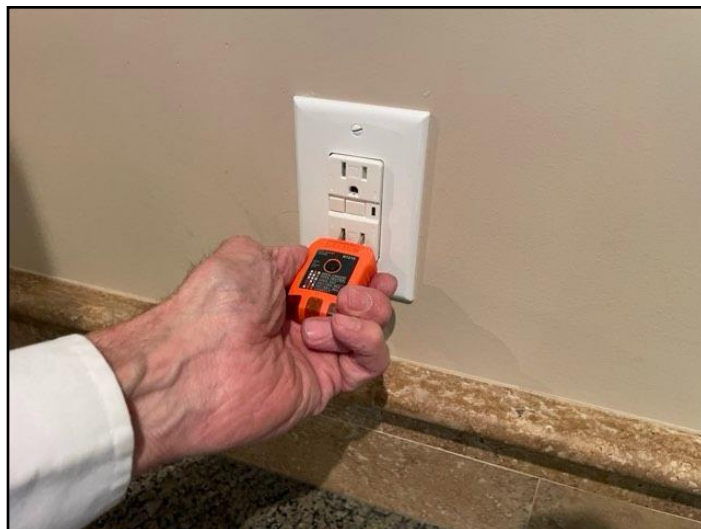
Condition: • [Damage](#)

Damage

Task: Repair / Replace

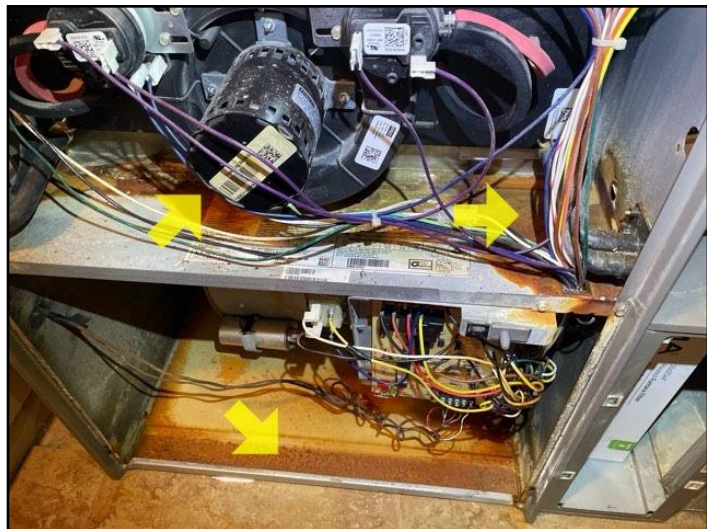
Condition: • Water stains/rust

This is typically caused by condensate leakage from the heat exchanger or induced draft fan.

Water stains/rust

Task: Although no active leakage was noted on testing during this inspection, a specialist should check this during annual servicing.

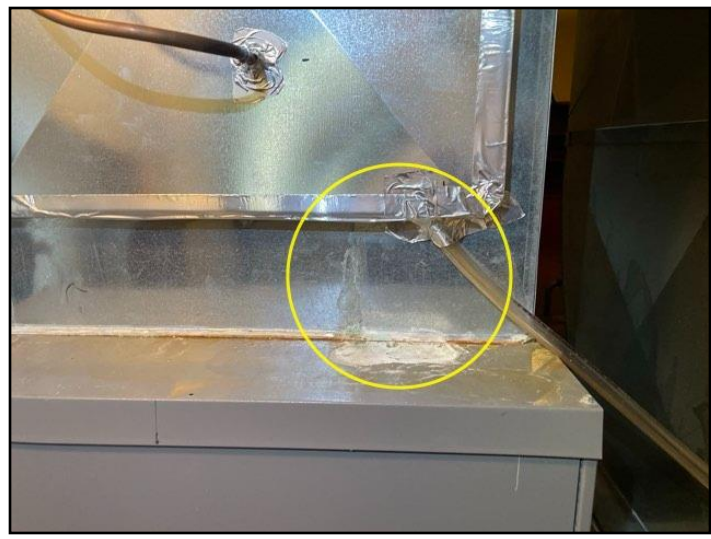
Condition: • [Leak](#)

Leak

Task: Further evaluation / Repair

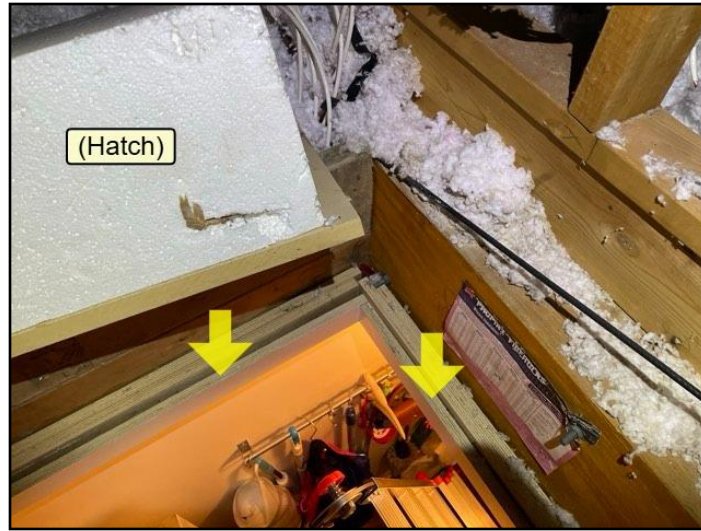
Not weatherstripped

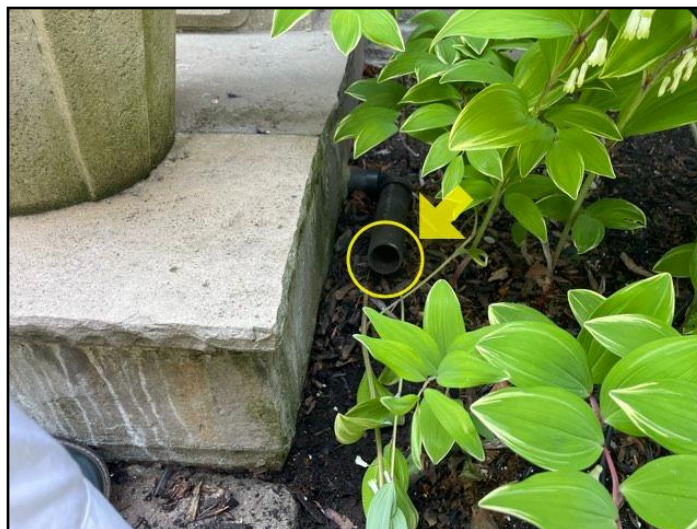
Condition: • [Discharges less than 6 feet from home](#)

Discharges less than 6 feet from home

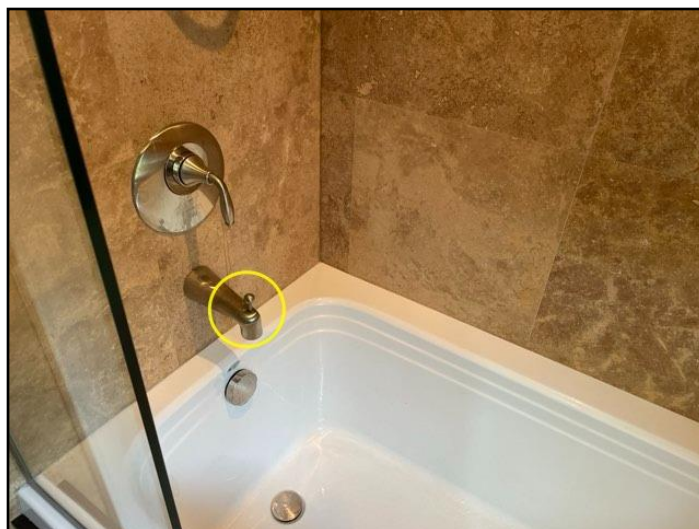
Condition: • [Shower diverter inoperative or defective](#)

Shower diverter inoperative or defective
