## **Your Inspection Report**

# 419 Hillsdale Avenue East Toronto, ON M4S 1T9

INSPECTION DATE: Monday, November 3, 2025

RE: Report No. 95158 419 Hillsdale Avenue East Toronto, ON M4S 1T9

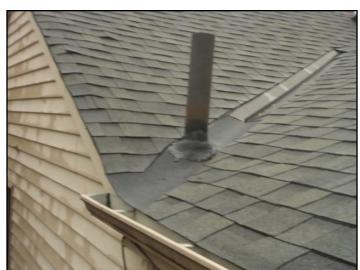
Vulnerable area- plumbing stack in valley

Ensure stack remains well sealed

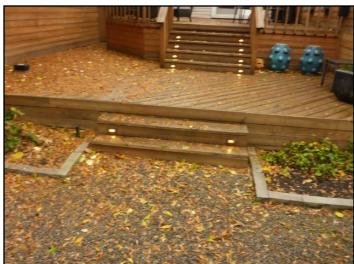
Missing railings at lower deck

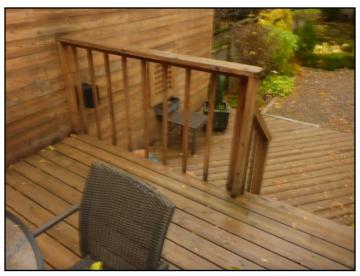
Condition: • Openings between spindles (balusters) too large

Large openings at rear deck railing may create a fall hazard, particularly for small children that will want to play here.

Openings between balusters too big

Task: Improve Time: If necessary

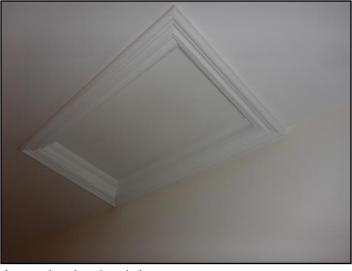
Condition: • NO ACCESS to the attic area

Access hatch painted shut

Task: Provide access and inspect to verify there are no issues with the structure, insulation, etc.

Time: As soon as practical.

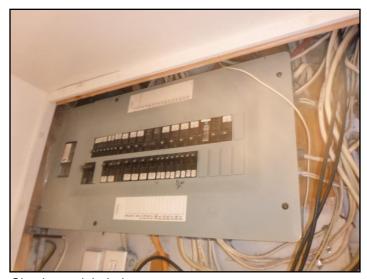
Condition: • Circuits not labeled

Circuits not labeled

Task: Correct

Time: If/as necessary

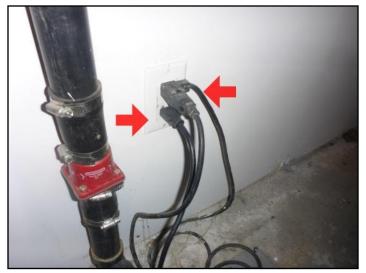
Condition: • Dedicated circuits needed

Dedicated circuits needed

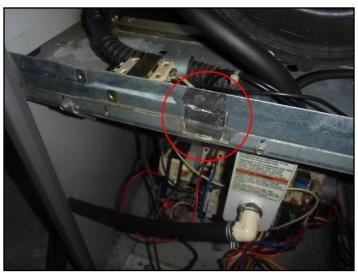
Condition: • Fan cover/access door interlock/safety switch inoperative

Blower door switch taped over

Time: Less than 1 year

Cost: Minor

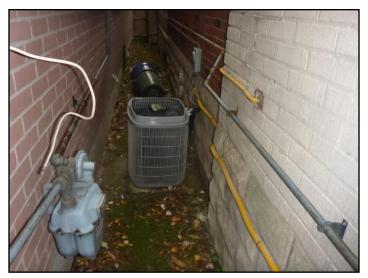
Air cooled- outdoor unit

**Condition:** • Air conditioner past typical life expectancy

The central AC unit is 23 years old and should be considered beyond its typical lifespan. Continue to operate and service unit until replacement is required.

Task: Replace Time: Unpredictable Cost: \$3,000 - \$6,000

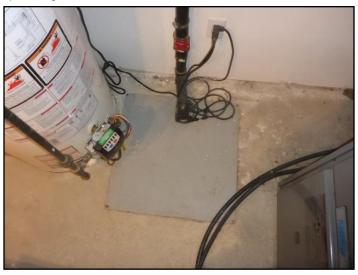
The sump pump is part of waterproofing work that was done in the basement. Confirm the setup with the seller.

Sump pump

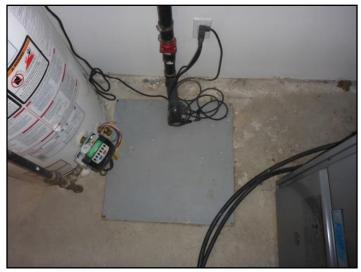
Condition: • Sump cover not removed

Sump cover is a metal plate screwed to the concrete floor. This panel was not removed at the inspection but the pump could still be tested (it was working). Improve access to this equipment: make the pump cover easier to remove so basic inspection and maintenance on the pump can be performed.

Sump cover not removed

**Location**: Furnace room **Task**: Improve Access

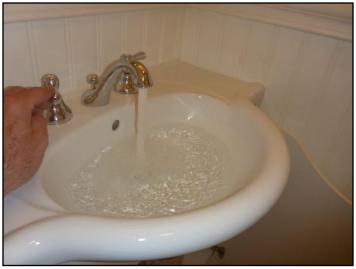
Condition: • Slow drains

Slow drain

Task: Correct

Time: Less than 1 year

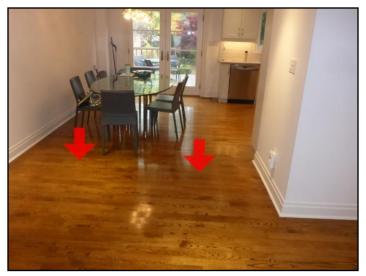
Condition: • Sloped flooring

There is a noticeable hump in the floor when you walk from the original house to the rear extension. A fairly common occurrence in houses that have had this type of renovation work done.

Hump in finished floor

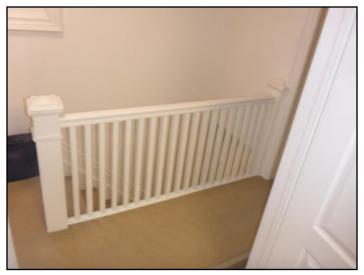
Condition: • Too low

Railings are typical for a house of this age but low by modern standards.

Low railing at hallway
